Arboricultural Report

Tree Survey,
Arboricultural Impact Assessment &
Arboricultural Method Statement

In relation to the Large-Scale Residential Development at:
Main Street/R125 and Ballybin Road
Ratoath
Co. Meath

230815-PD-11-A

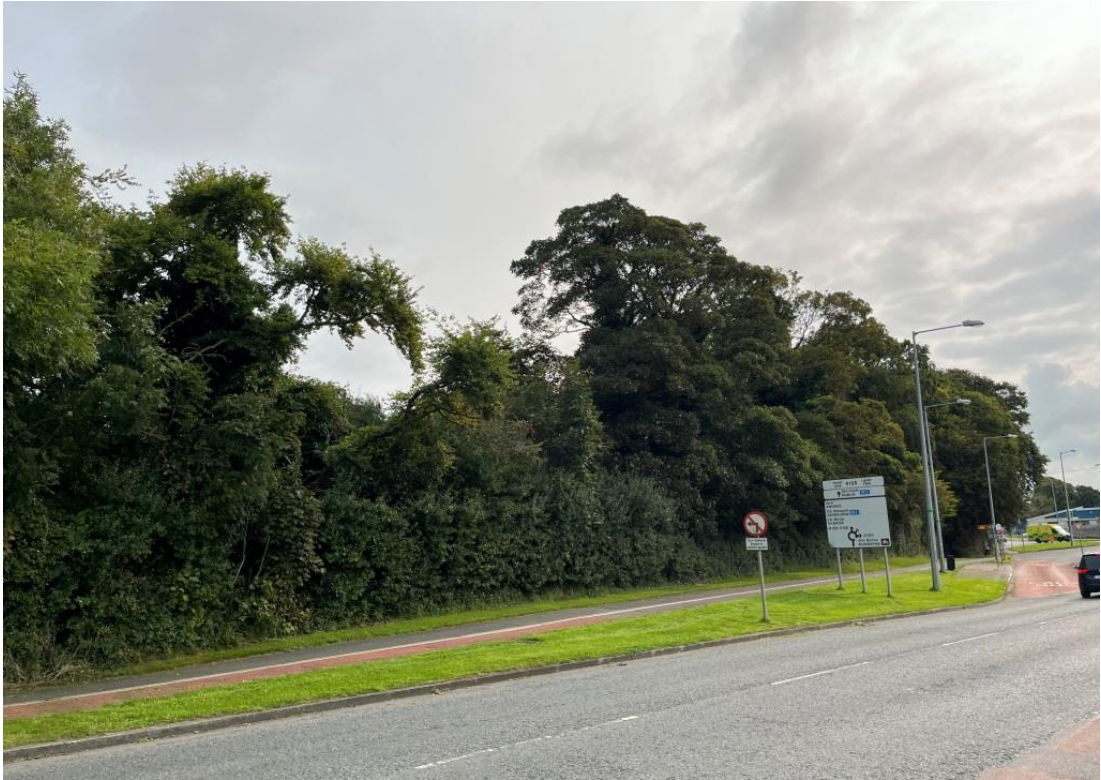
Photo 1: View of the existing tree and hedgerow located along the southern boundary of the site, adjacent to Main Street/R125.

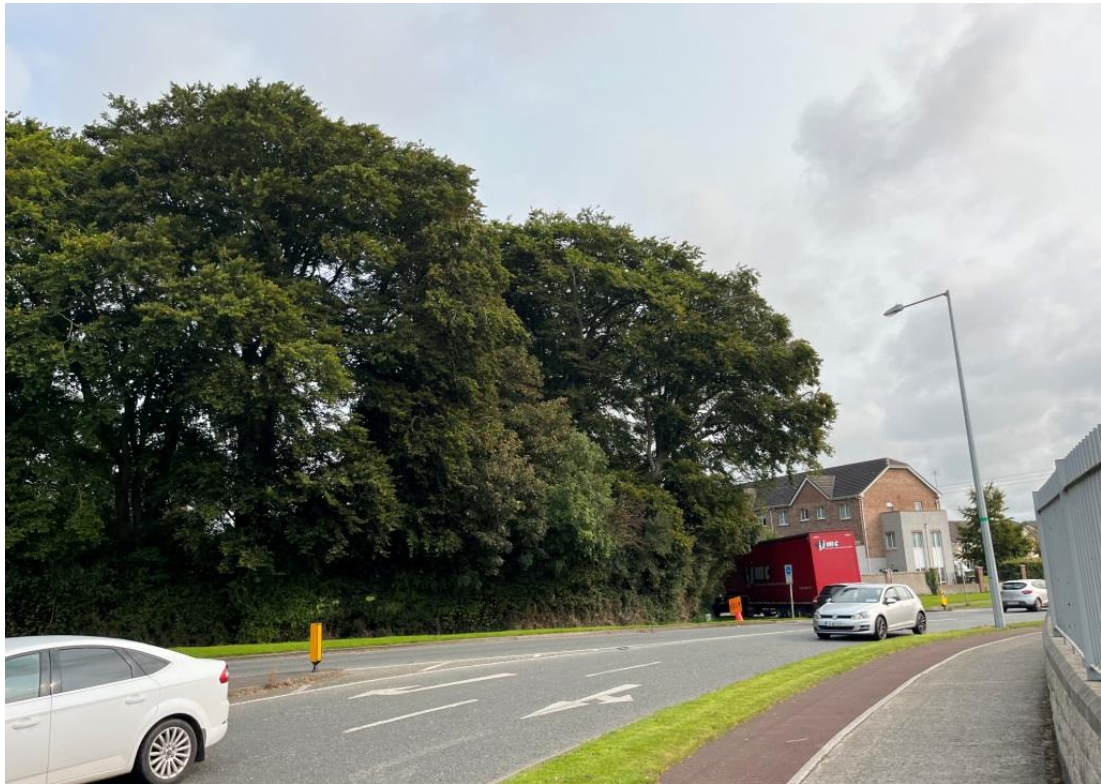
Photo 2: View of the existing tree and hedgerow located at the corner of Main Street/R125 and Ballybin Road.

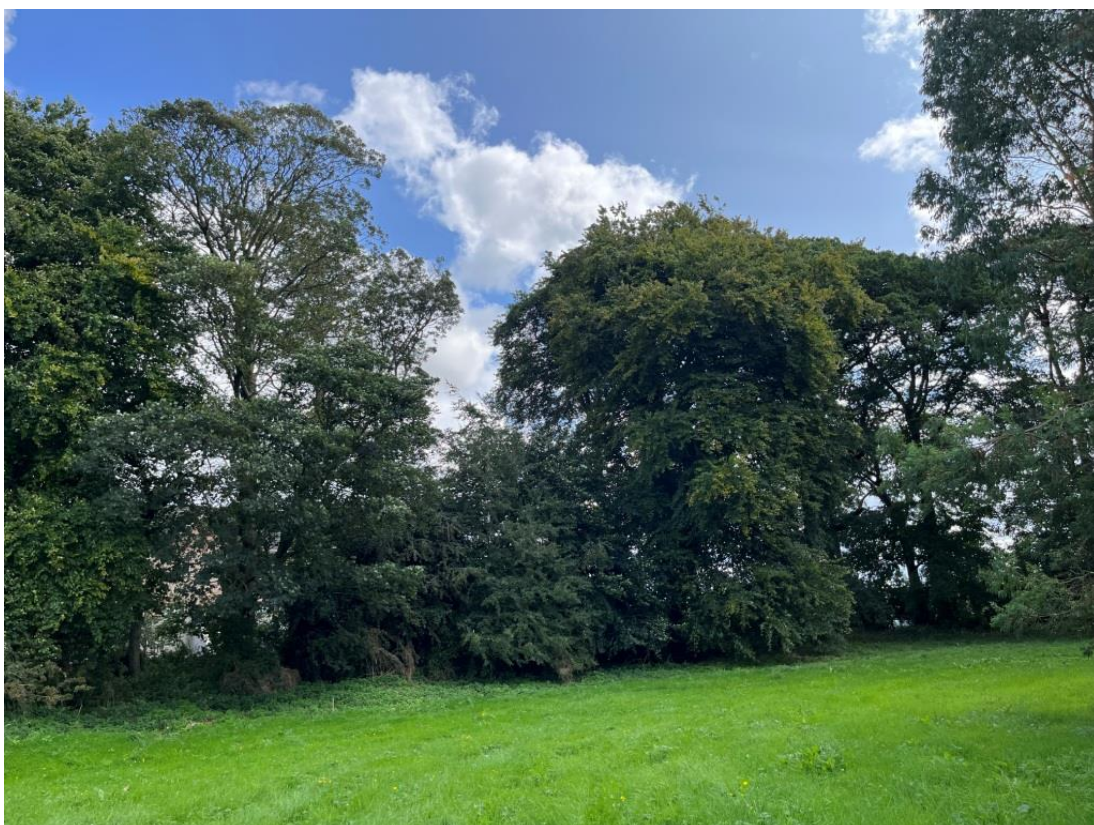
Photo 3: View of the existing tree and hedgerow line located along the eastern boundary of the site, adjacent to Ballybin Road. Image taken from within the grounds of the site.

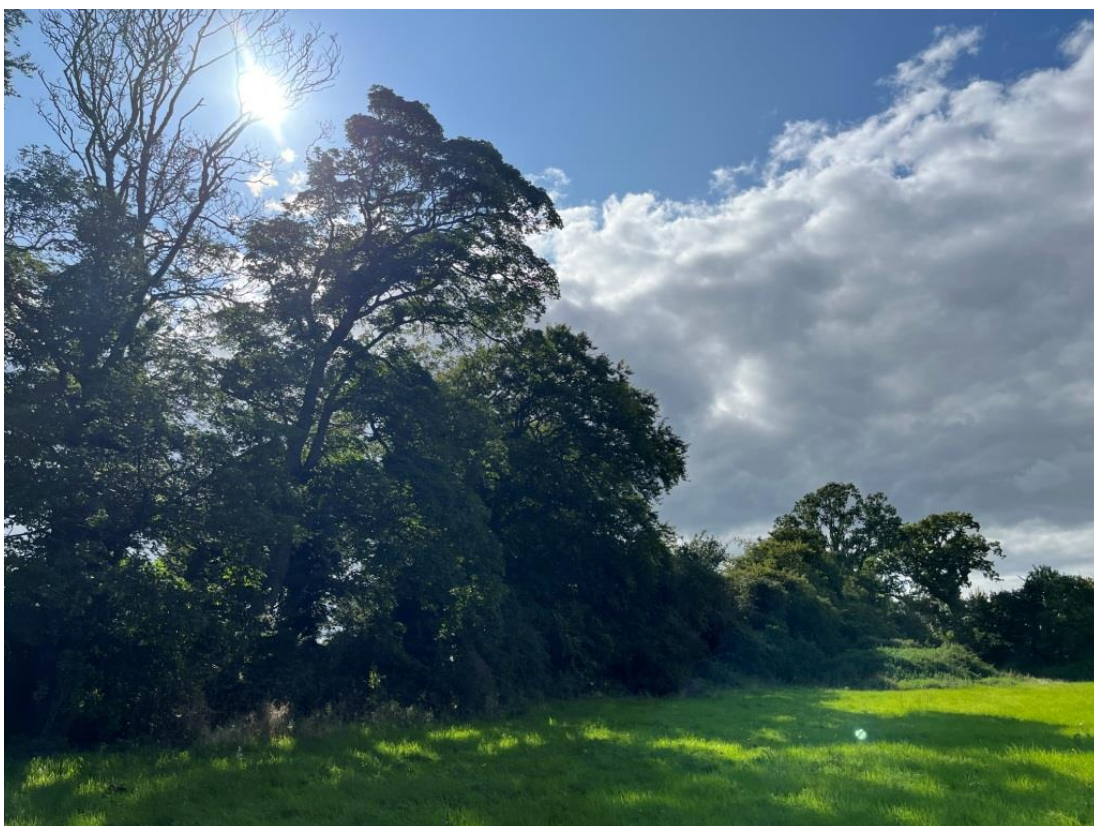
Photo 4: View of the existing tree and hedgerow located along the southern boundary of the site. Image taken from within the grounds of the site.

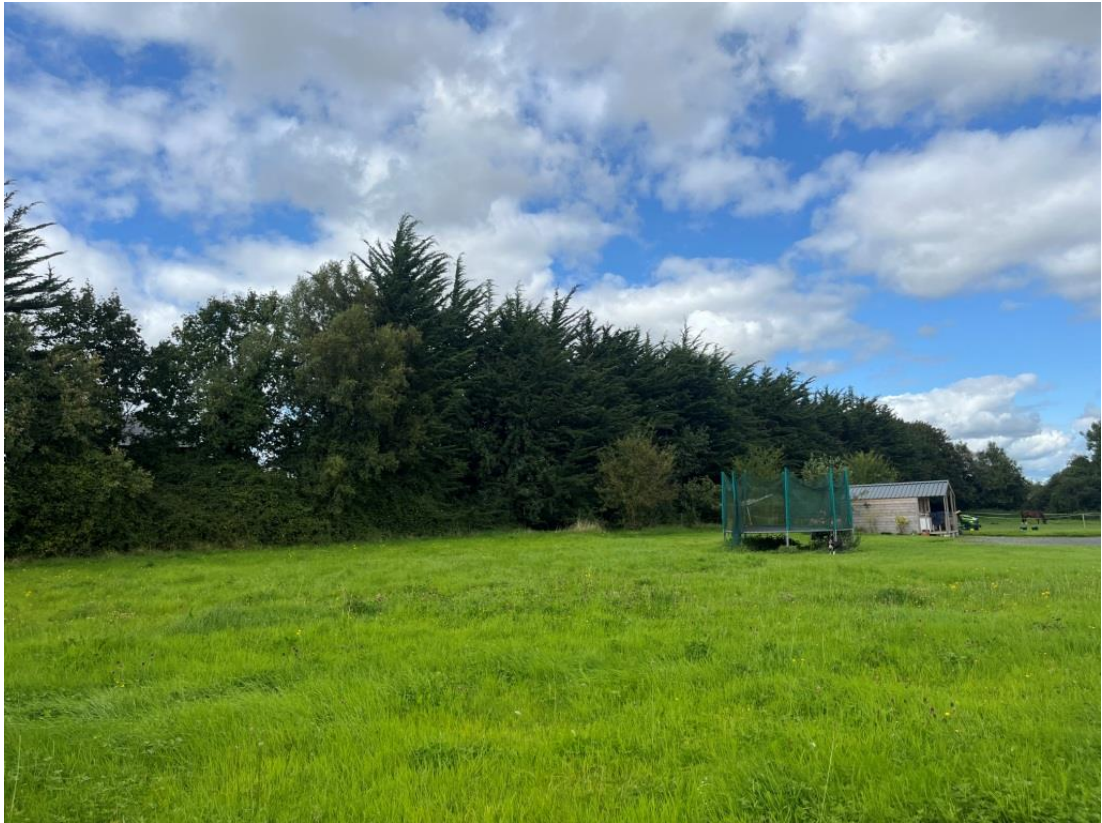
Photo 5: View of the western boundary tree group which consists mainly of Monterey cypress.

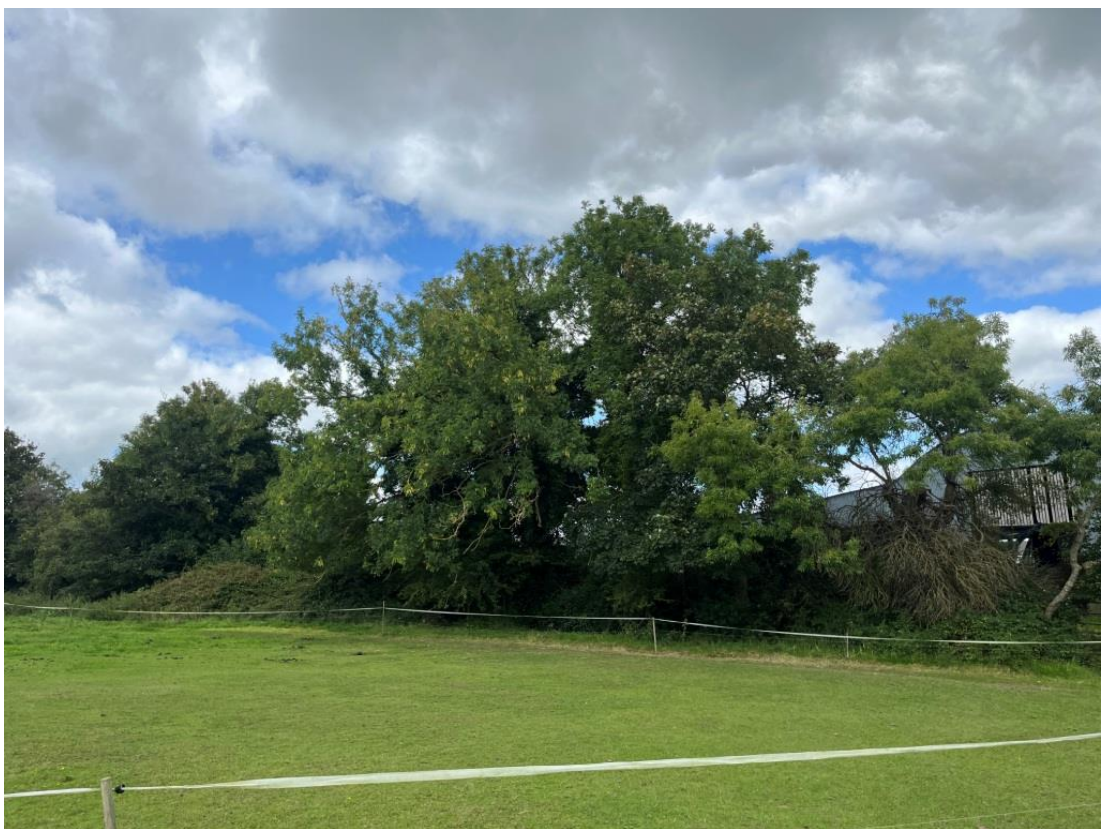
Photo 6: View of the central native hedgerow and ash tree line located between the agricultural shed and existing residential property.

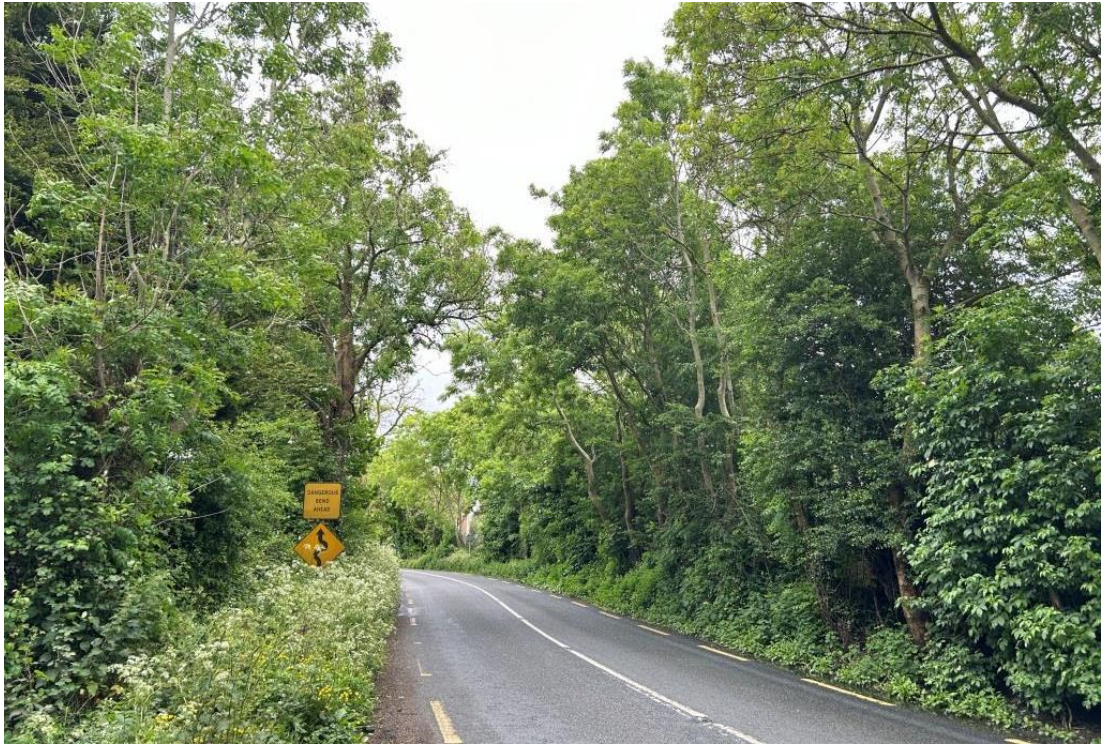
Photo 7: View of the trees and hedgerows located on either side of the Ballybin Road to the north of the main development site.

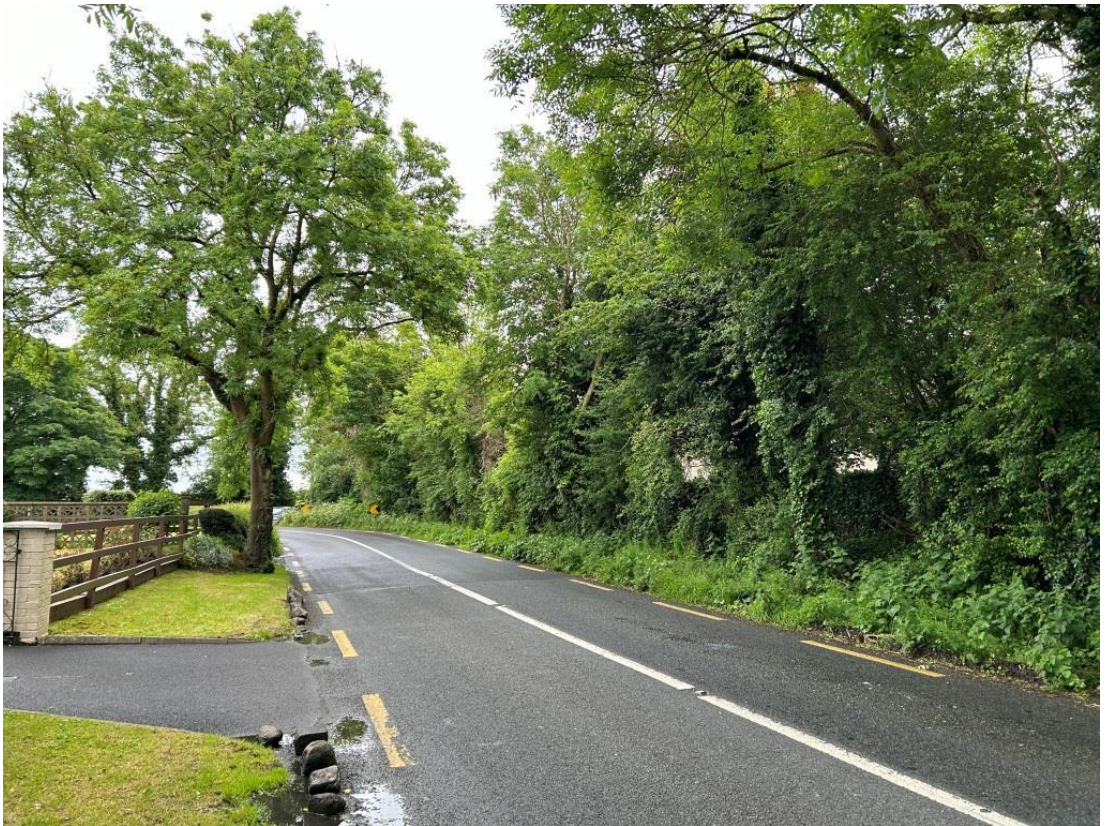
Photo 8: View of the tree T472 and the tree and hedgerow group G507 along the Ballybin Road.
